SHORE EROSION CONTROL REPORT

**ARUNDEL-ON-THE-BAY
PROPERTY OWNER'S ASSOCIATION
P.O. Box 4665
Annapolis, MD 21403**

July 2009

ARUNDEL ON THE BAY PROPERTY OWNERS ASSOCIATION ANNE ARUNDEL COUNTY, MARYLAND

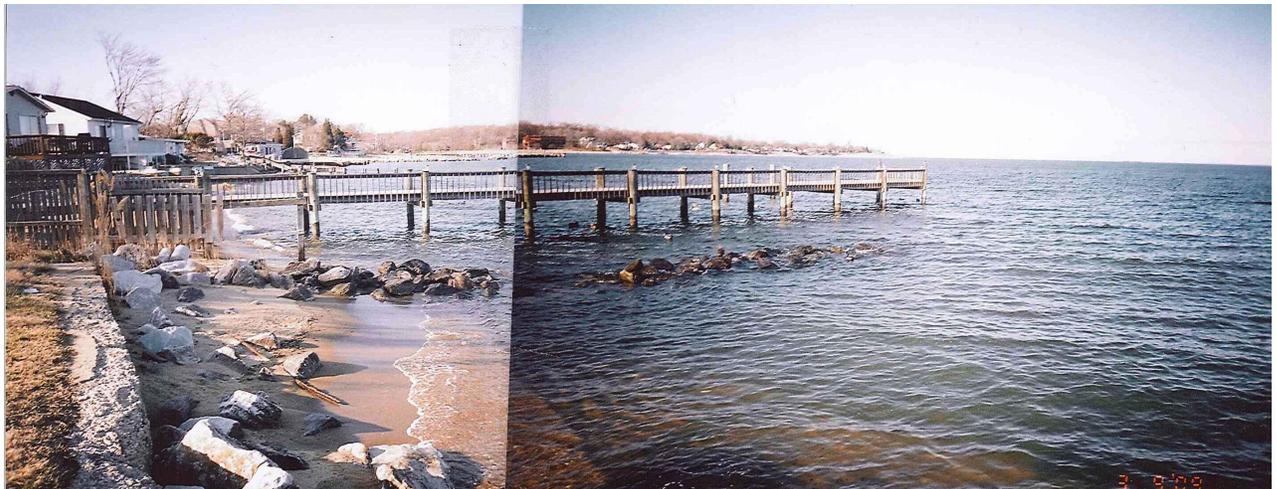
Photo #3

Little or no armor stone is located outboard of the concrete bulkhead at the end of Cedar Avenue (Sta. 0+00) (Photo #3) or the timber bulkhead located between Magnolia Avenue and Hollywood Avenue (Sta. 33+00) (Photo #4 & #5).

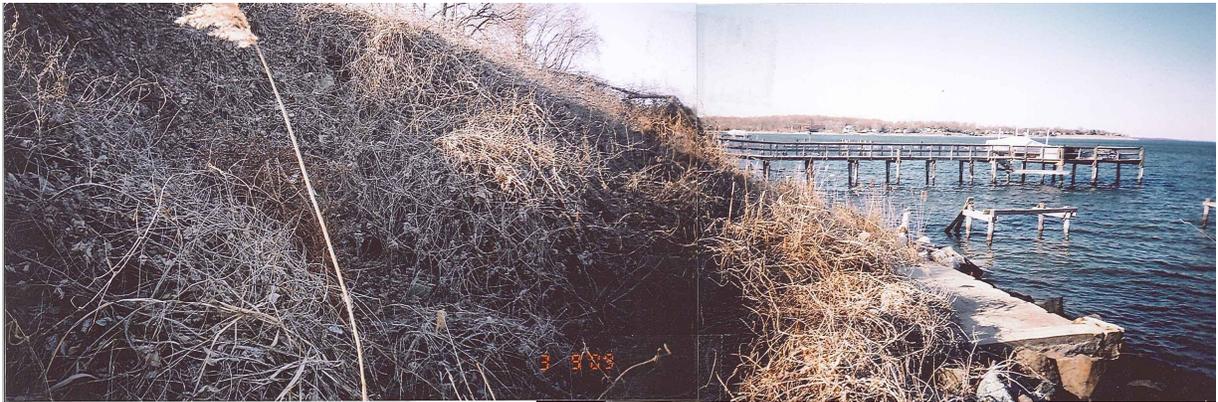
Photo #7

Apparently due to the lower elevation of the concrete bulkheads between Sycamore and Redwood Avenues and at Linden Avenue, erosion of the high banks landward and adjacent to the concrete bulkheads occurred during Hurricane Isabel. Further erosion of the bank could potentially threaten the stability of the sewerage system located landward of the banks at this area along Chesapeake Walk. The bank at the northerly end of Chesapeake Walk (about 100' north of Sycamore Avenue) has eroded to within about 15' of the sewer line (Sta. 7+20) (Photo #6). Significant erosion has also occurred landward and adjacent to the storm damaged concrete structure in the vicinity of Linden Avenue (Sta. 15+00) (Photo #7).

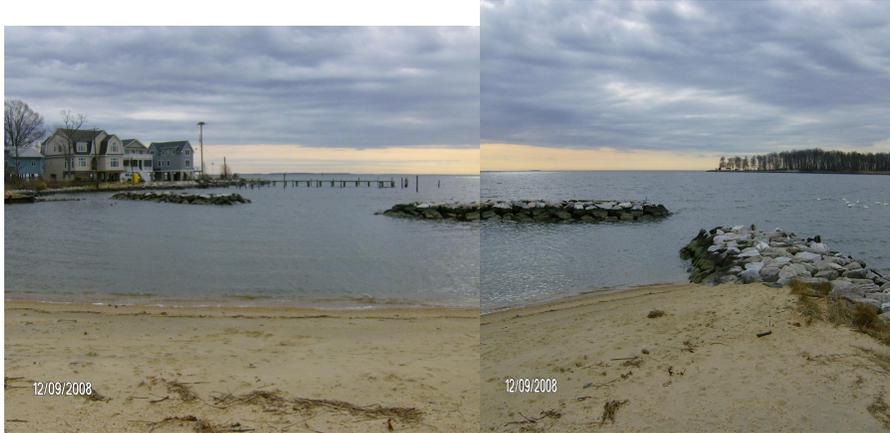
Photo #8

The top elevation of two existing stone breakwaters and terminal stone groin constructed in the late '80s at the community beach are on the order of +2.5' MLW (Sta. 49+00) (Photo #8) which is 1.5' lower than the design recommendations previously provided by AMA. The lower crest heights are apparently allowing wave energy to overtop the structures thereby creating excessive sand movement land-ward of the structures and erosion landward of the low profile timber bulkhead.

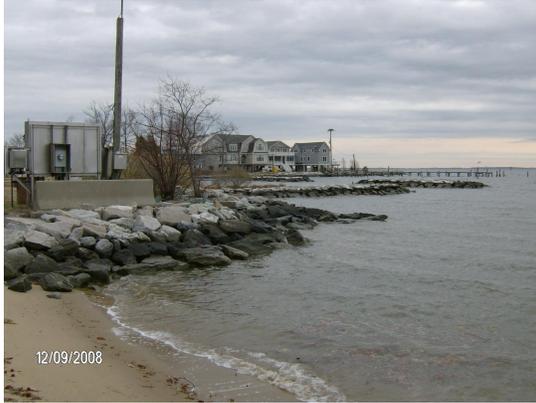
Photo #9

Low profile stone groins are randomly spaced along the shoreline beginning at the community's beach (Photo #9) and extending westerly beyond Rockway Avenue. A stone scour apron is at the storm drain outfall located east of the community marina. The top elevations of these structures and the undersized armor stones are providing limited shore erosion control protection.

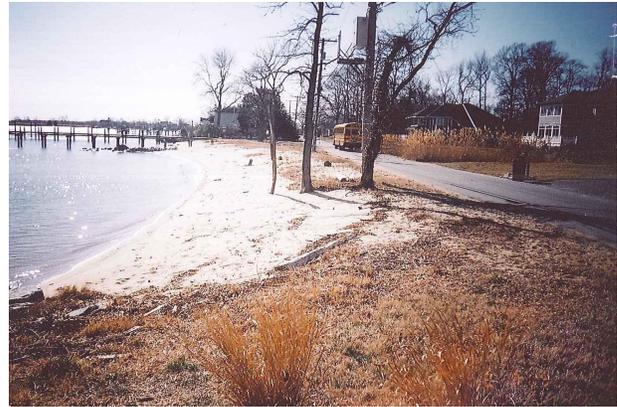
Photo #10

The primary function of groins is to prevent or minimize the littoral transport of sand along a shoreline. Unless a shoreline is located in a sheltered area with limited offshore fetches or is supplemented with additional erosion control structures (i.e.: breakwaters) located off-shore to minimize the erosive energy of waves, groins are typically not recommended as a shore erosion control measure. Over time, storm generated waves have a tendency to seasonally shift the shoreline, ultimately migrating the mean high water line landward. This appears to be the scenario that has occurred between the community beach and the marina along Magnolia Avenue. The existing beach has migrated landward to about 25' from the paved roadway (Sta. 50+00) (Photo #10).

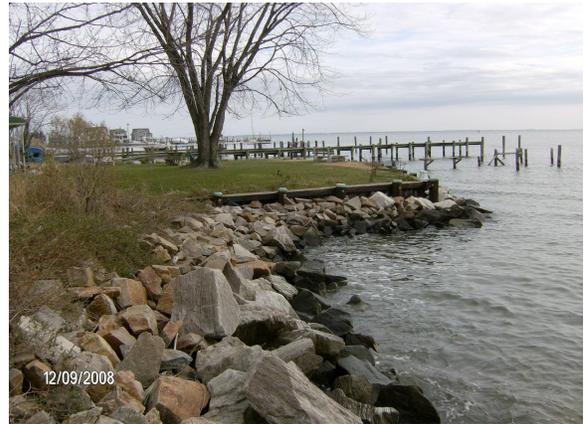
Photo #13

Further, armor stone does not extend to the top of the bulkheads west of Rockway Avenue (Photo #13 and #14), thereby exposing the structures to the ravages of storms. Also, little or no armor stones are located outboard of the timber bulkheads at the Community's beach, east of Rockway Avenue, or immediately south of Magnolia Avenue (Sta. 63+00) (Photo #15)

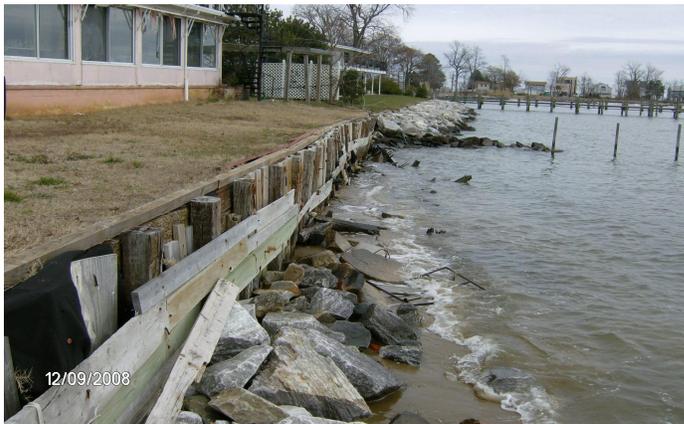
Photo #16

The existing timber bulkheads appear to be generally in good condition except for the structures located immediately east of Rockway Avenue (Sta. 55+00) (Photo #16) and south of Magnolia Avenue (Sta. 62+00) (Photo #17). The structure located immediately east of Rockway Avenue is in a general state of disrepair and is reaching the end of its serviceable life. The lawn behind the timber structure near Magnolia Avenue has numerous sumps. The top elevation of the existing low profile timber bulkhead located landward of the stone breakwaters at the Community's beach (Sta. 48+00) is on the order of +2.5' MLW

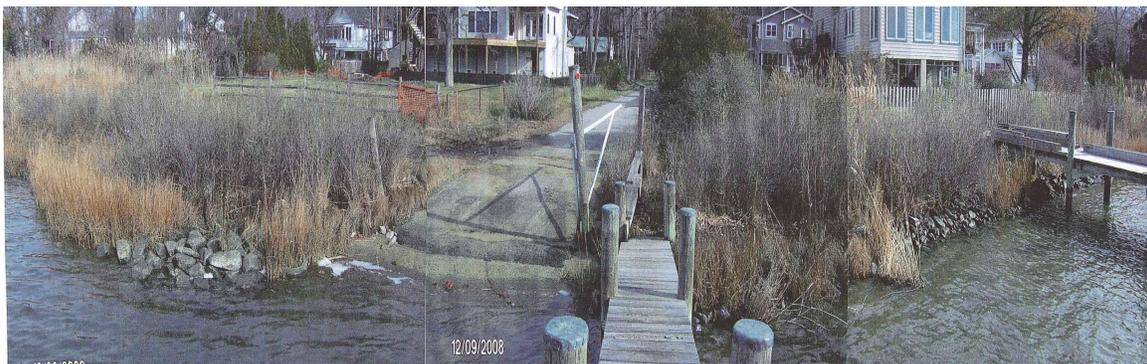
Photo #18

“Fishing Creek Frontage”: Approximately 3920’ of shoreline along the “Fishing Creek Frontage” (Figure #5) extends from Magnolia Avenue northerly to Cedar Avenue. Various existing shore erosion control protection measures include concrete bulkheads, timber bulkheads, stone revetments, stone filled gabion baskets, combinations of concrete/timber bulkheads supplemented with stone revetments and “Living Shoreline” type projects. Approximately 200’ of shoreline located south of Walnut Avenue is unprotected and heavily inundated with phragmites. Numerous piers line the shore and two boat houses/shelters extend into the Creek. The Community’s boat ramp is located at the end of Redwood Avenue (Sta. 91+00) (Photo 18).

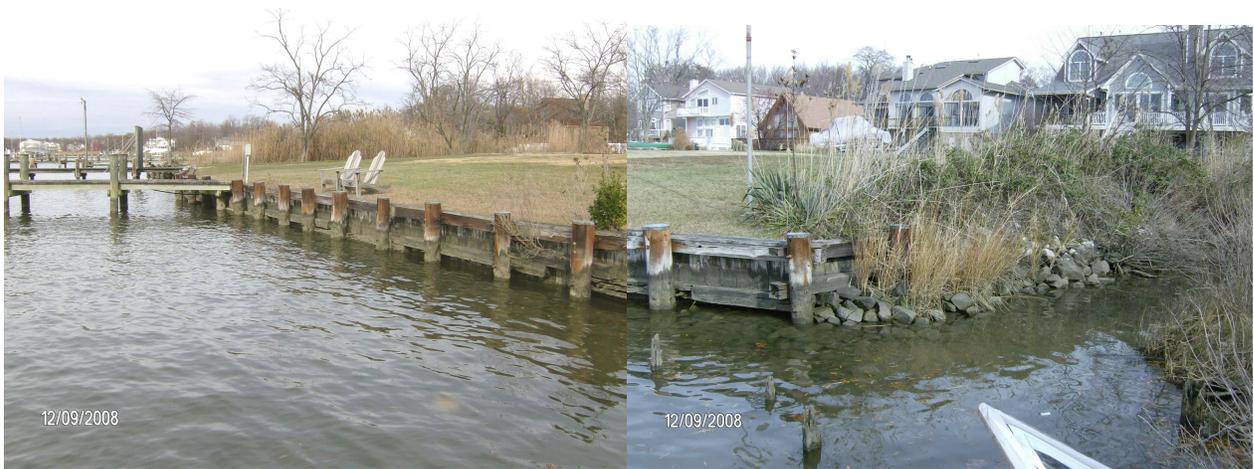
Photo #21

Except for the low profile horizontal beamed bulkhead located between Myrtle and Chestnut Avenues (Sta. 80+50) the existing timber bulkheads within the Creek are in a general state of disrepair. The timber structure that protects the point south of Hollywood Avenue (Sta. 69+00) has numerous decayed structural members. Filter fabric has been placed along the landward side of the sheeting which appears to have been previously reinforced with horizontal timber boards. Likewise, the structure located at Saratoga Avenue immediately north of Chestnut Avenue (Sta.84+00) (Photo #21) also has decayed structural members and is also reaching the end of its serviceable life.

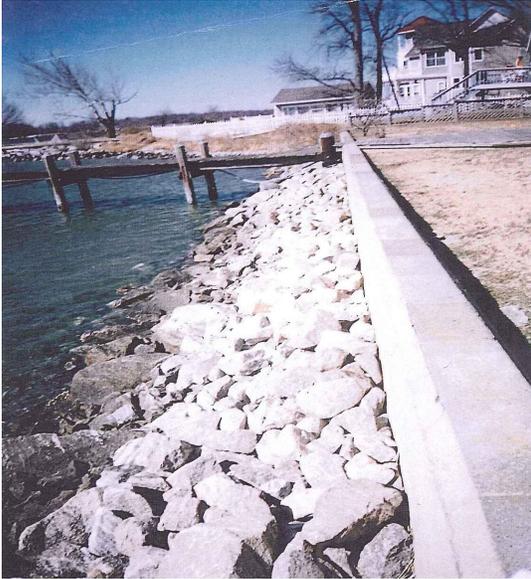
Photo #22

The existing concrete bulkhead located north of Magnolia Avenue (Sta. 64+50) (Photo #22) is constructed of concrete blocks and appears to be in reasonably good condition although a sink hole has developed north of the existing pier. The top of another concrete structure that protects the point north of Myrtle Avenue (Sta. 79+00) is spalling. There is evidence that concrete was poured over the armor stone after it's initial placement. Although aesthetically unpleasing, the poured concrete/armor stone structure is apparently soil-tight since there is no evidence of soil loss behind the structure (Photo #23).

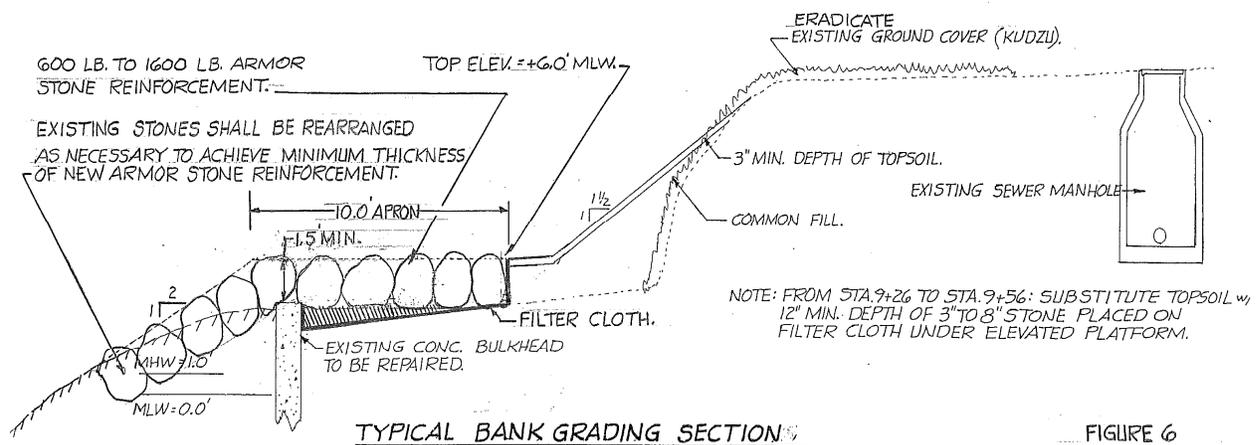
Figure 6

a 15 year storm event). The recommended design standard for erosion control structures in the Chesapeake Bay region is a 25 year storm event. Therefore, the structure is regularly overtopped during the design storm event, thereby potentially eroding the high vertical banks located landward of the structure.

The County's sewer line parallels the shoreline from Walnut Avenue to Linden Avenue. During Hurricane Isabel, the bank eroded to within approximately 15' of the sewer line in the vicinity of Sycamore Avenue (Photo #6). Therefore, to prevent further erosion during severe storm events and potential damage to the existing sewerage system, AMA recommends that the concrete structure's surface be parged and any cracks repaired prior to extending the existing stone revetment (located channel-ward of the concrete bulkhead) higher with a stone apron constructed over the bulkhead as shown in Figure 6. Further, the bank should be graded at a stable slope, the kudzu eradicated and the graded bank's surface topsoiled and seeded. The estimated cost of construction is on the order of \$190K to \$260K.

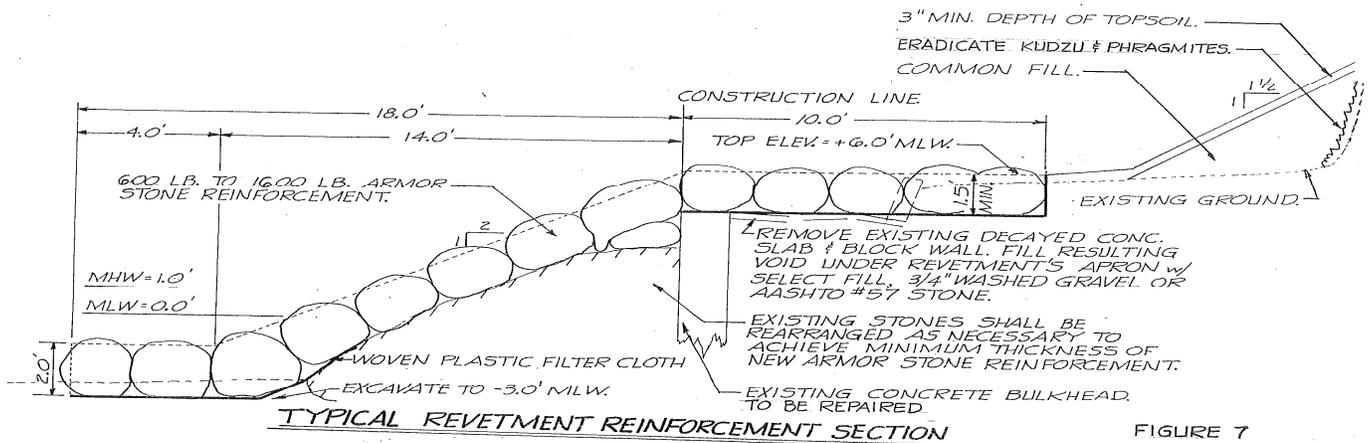
Figure 7

- **AREA 'C' Station 15+00 to Station 16+50 [Priority #5]:** Similar to Area "B" referenced above, the existing concrete bulkhead's top elevation at this area is on the order of 4.3' MLW. Erosion has occurred landward and on the flanks of the existing concrete bulkhead. Therefore, to prevent further erosion during severe storm events and potential damage to the existing sewerage system landward of

this area, AMA recommends that the damaged concrete slab and block wall be removed, the concrete structure's surface be parged and any cracks repaired prior to extending the existing stone revetment (located channel-ward of the concrete bulkhead) higher with a stone apron constructed over the bulkhead as shown in Figure 7. Further, the steep bank should be graded at a stable slope, the kudzu eradicated and the graded bank's surface topsoiled and seeded. The estimated cost of construction is on the order of \$50K to \$70K.

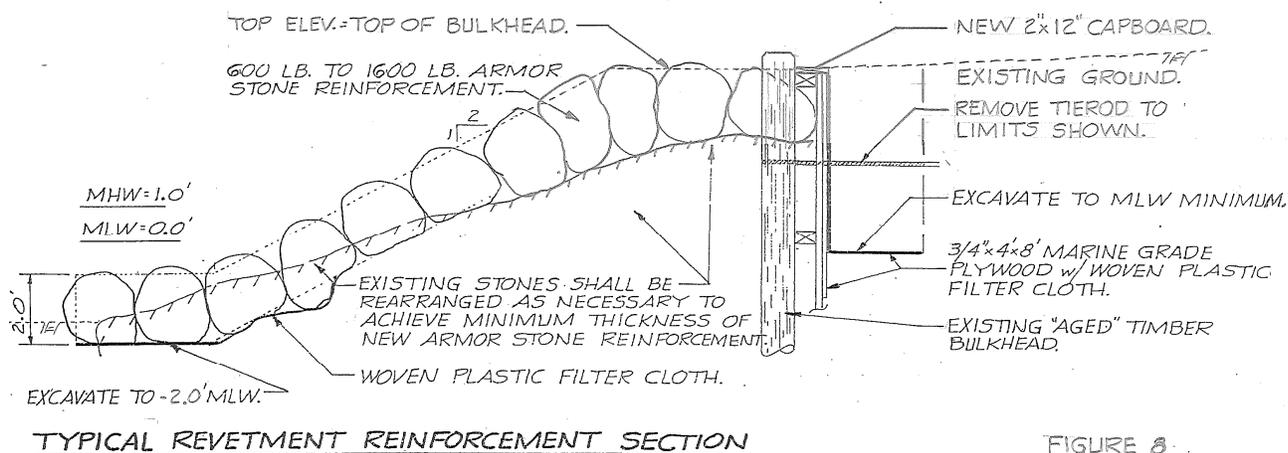
Figure 8

- AREA 'D' Station 20+40 to Station 21+60 [Priority #7]:** The majority of the visible timber structural components along this section of shoreline have decayed. Sumps and sink holes are randomly located along the land-ward side of the "aged" timber bulkhead which is an indicator that the sheeting is reaching the end of its serviceable life. Further, the existing armor stone located channel-ward of the bulkhead is generally undersized and does not extend to the top of the bulkhead. AMA recommends that the existing sheeting be enhanced, the undersized stone on the structure's surface be rearranged as necessary to allow placement of larger 600# to 1600# armor stone, and the top elevation of the armor stone be raised to the top of the bulkhead along the length of the structure as shown in Figure 8. The estimated cost of construction is on the order of \$35K to \$50K.

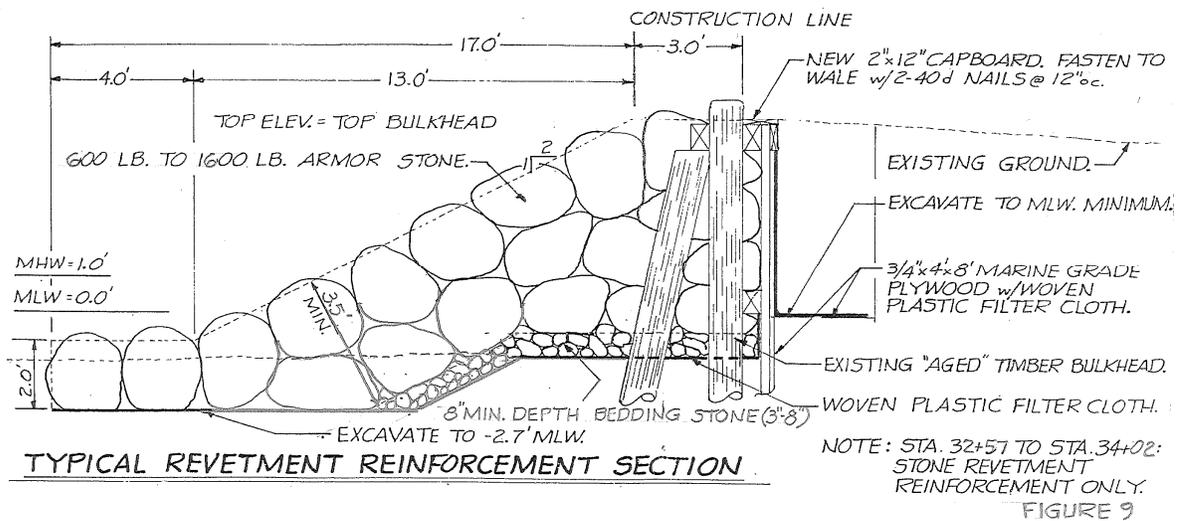
Figure 9

- AREA 'E' Station 30+90 to Station 32+57 [Priority #4]:** Numerous sink holes are located landward of the existing "aged" timber bulkhead which is an indicator that the sheeting is reaching the end of its life. Further, the property owner has stated that temporary repairs had recently been performed to prevent soil from washing into the Bay from under the sheeting. Records indicate that the bulkhead had previously been repaired in the '80s. Although stone reinforcement was also recommended at that time, placement of armor stone was not implemented. The approximate face height (distance from the top of the bulkhead to the Bay's bottom elevation) varies from 5' to 8'. The ground elevation channelward of the existing bulkhead is three (3') feet deeper now compared to the elevation in the early '80's. Due to the age, the numerous sink holes and the face height of the timber bulkhead, AMA recommends that the existing sheeting be enhanced and stone reinforcement be placed along the length of the structure as shown in Figure 9. The estimated cost of construction is on the order of \$60k to \$85K.

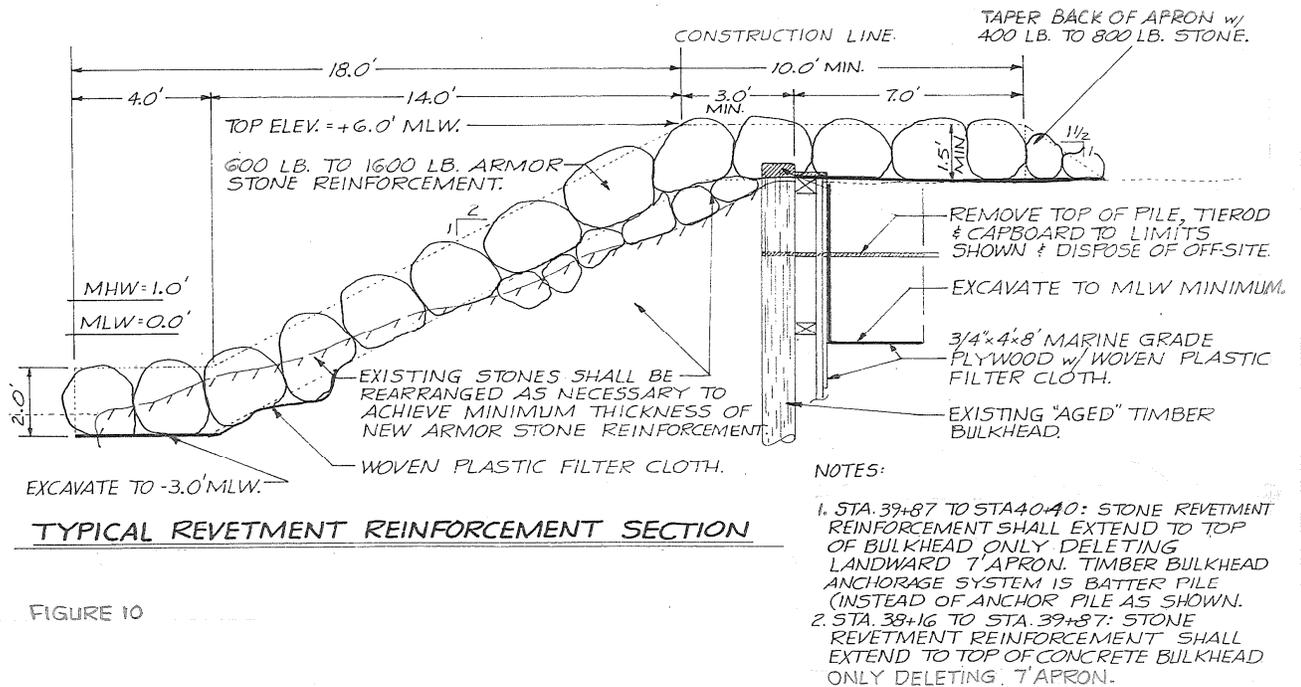
Figure 10

- AREA 'F' Station 40+40 to Station 43+22 [Priority #10/13]:** Land that protrudes into a water body generally has a tendency to experience greater erosion due to more frequent and severe wave attack during storm events. This area is an example of such an occurrence. Although the top elevation of the timber bulkhead is above existing grade (+4.5' MLW), overtopping has occurred as evidenced by the erosion landward of the structure (Photo #2). In addition, the sheeting has decayed along portions of the bulkhead where sumps have randomly developed along the landward side of the sheeting. Further, the armor stone located channel-ward along portions of the bulkhead is undersized. AMA recommends replacing the undersized stone with 600# to 1600# armor stone, and extending the stone higher with a stone apron constructed over the bulkhead after the existing sheeting is enhanced as shown in Figure 10. The estimated cost of construction is on the order of \$75K to \$100K.

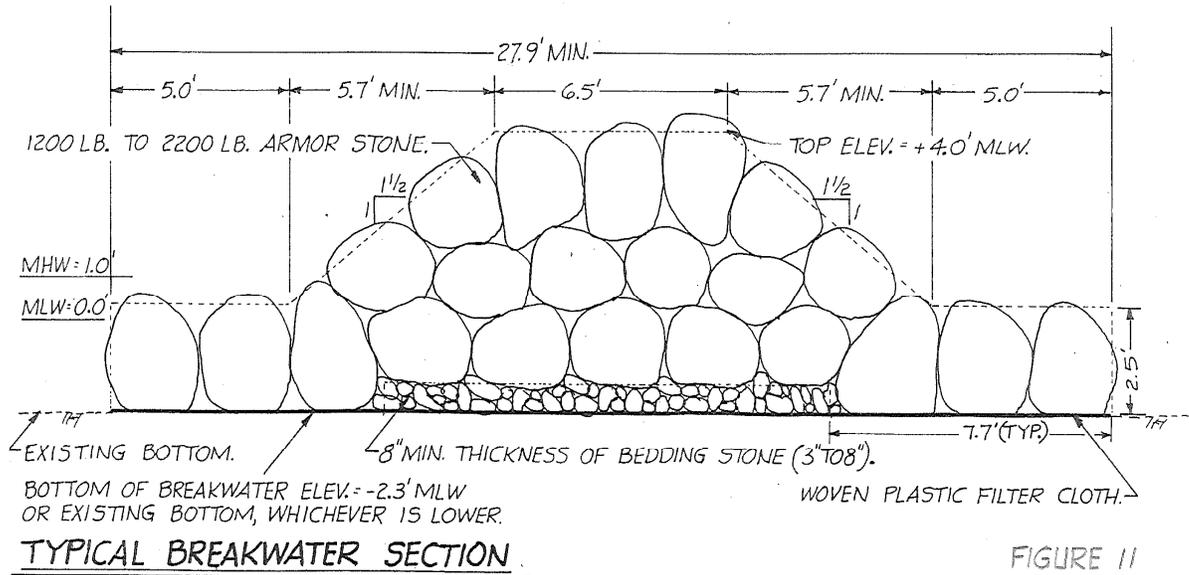
Figure 11

- AREA 'G' Station 49+50 to Station 53+50 (Priority #14):** The randomly placed stone groins and sand beach located along this area are providing limited storm protection. The existing beach has migrated landward to about 25' from the paved roadway (Photo #10). Therefore, at a minimum, AMA recommends construction of three segmented stone breakwaters, as shown in Figure 11, an intermediate stone groin and enhancement of the existing westerly terminal groin as shown in Figure 12 to provide an additional buffer between the MHW line and the existing roadway and overhead utilities. The stone groin will minimize sand transport along the existing beach. Upon extension of the existing storm drain outfalls, the beach area could either be re-nourished with imported commercially purchased sand material or with material obtained from nearby mechanical dredging projects as shown in Figure 13. Both commercially purchased sand or dredged sand material would need to meet MDE size requirements previously referenced in this report. Beach nourishment could be undertaken either immediately after construction of the breakwaters and groins, at a later date when additional funds become available or whenever a nearby mechanical dredging project, having sand material compatible

for beach nourishment, requires a disposal site. The estimated cost of construction for the breakwaters and groins is on the order of \$140K to \$190K whereas extension of the storm drains and placement of commercially purchased sand is on the order of \$50k to \$60K. Using dredged sandy material as a source for beach nourishment should require minimal or no cost to AOTB.

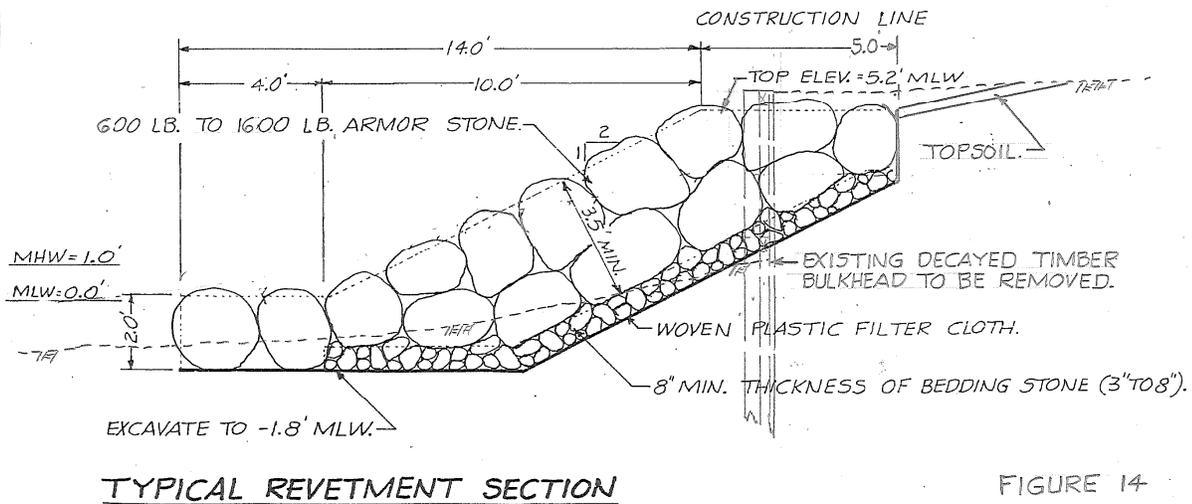
Figure 14

- AREA 'H' Station 55+50 to Station 56+50 [Priority #1]:** The existing timber bulkhead is in a general state of decay and has reached the end of its serviceable life. Due to the condition of the structure, AMA recommends that the bulkhead be removed and replaced with a new stone revetment as shown in Figure 14. The estimated cost of construction is on the order of \$50 to \$65K.

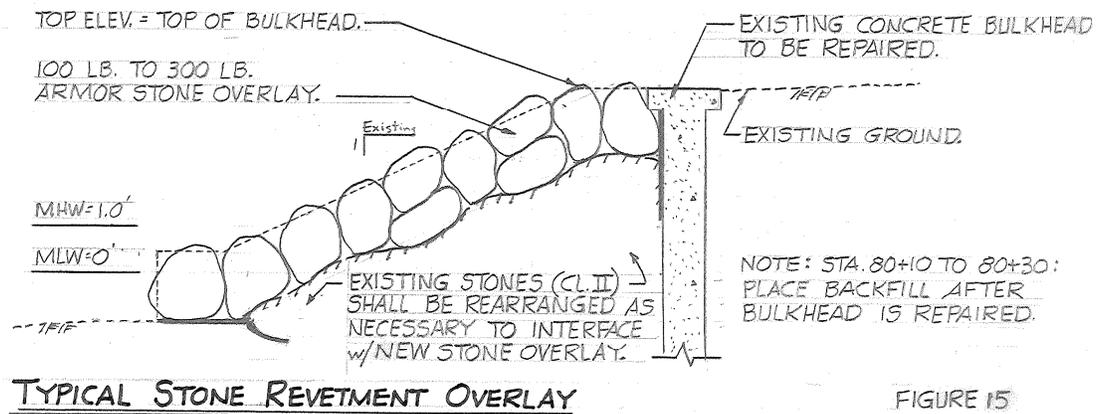
Figure 15

- **AREA 'K' Sta. 64+40 to Sta. 65+30 [Priority #6]:** A sink hole has developed landward of the concrete block bulkhead north of the existing pier and has been partially filled with rubble. The class I riprap located channel-ward of the bulkhead does not extend to the top of the structure and the existing ground's surface landward of the bulkhead is about 8" lower than the top of the structure. AMA recommends repairing the bulkhead in the area of the sink hole and placing an armor stone overlay on the existing class I riprap using 100# to 300# armor stone as shown in Figure 15. The cost of construction would be on the order of \$10K to \$15K.

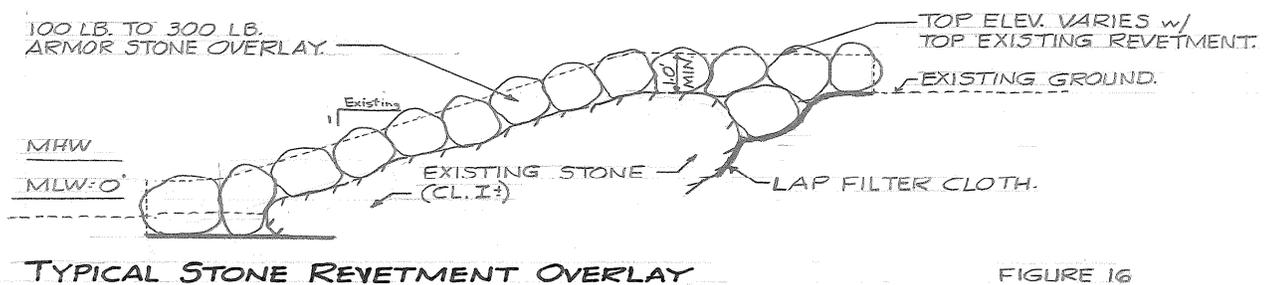
Figure 16

- **AREA “L” Sta. 75+00 to Sta. 76+30 [Priority #15]:** Erosion is extending into the lawn behind the low profile stone revetment along the length of the shoreline, apparently due to the lack of filter cloth (along the revetment’s land-ward interface) and wave energy overtopping the structure. AMA recommends that filter cloth be placed under and land-ward of the existing stone and new 100# to 300# armor stone be placed over and land-ward of the existing revetment as shown in Figure 16. The estimated cost of construction is on the order of \$13K to \$18K.

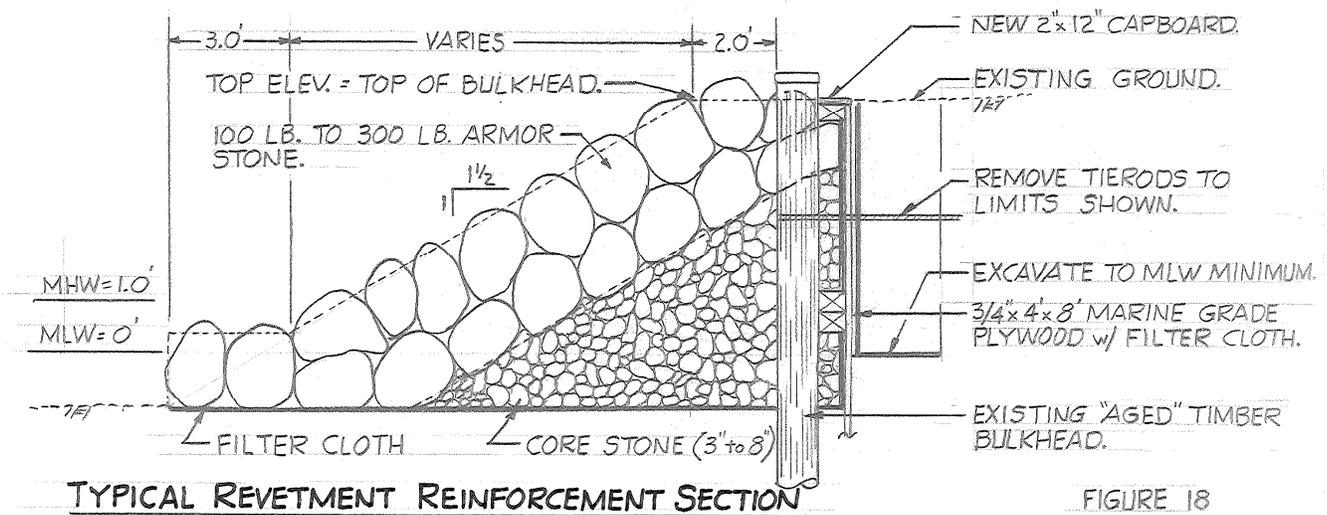
Figure 18

- AREA 'N' Sta. 83+30 to Sta. 85+10 [Priority #2]:** The soil has settled and numerous sink holes were noted along the landward side of the decayed timber bulkhead during the site visit. The structural components of the existing timber bulkhead, particularly the timber wale system, appears to be reaching the end of their serviceable life. Therefore, AMA recommends that 100# to 300# armor stone reinforcement be placed on filter cloth channel-ward of the existing bulkhead and enhancement of the existing sheeting as shown on Figure 18. The structural replacement of the decayed timber bulkhead with construction of basically a stone revetment could present a challenge for obtaining approvals from the environmental agencies considering their preference for "Living Shorelines." The estimated cost of construction is on the order of \$80K to \$110K.

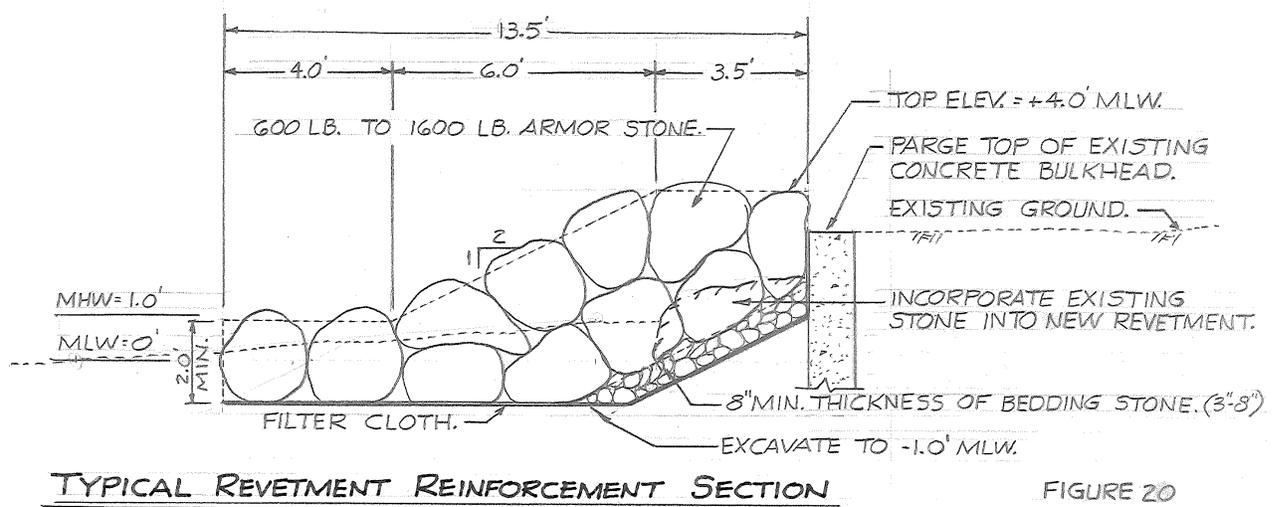
Figure 20

accumulated channel-ward of the existing concrete bulkhead, apparently originating from littoral transport along Oyster Cove Community's shoreline. Although the existing concrete bulkhead is significantly spalled along the top of the structure, no sink holes have developed land-ward of the structure. In order to maintain the future stability of the concrete bulkhead, AMA recommends that the concrete structure's surface be parged, and additional 600# to 1600# armor stone reinforcement be placed on filter cloth as shown in Figure 20. Further, AMA recommends that the existing stone groin be reconfigured and reconstructed using 600# to 1600# armor stone as shown in Figure 12. The estimated cost of construction would be on the order of \$10K to \$13K and \$15K to 22K respectively.

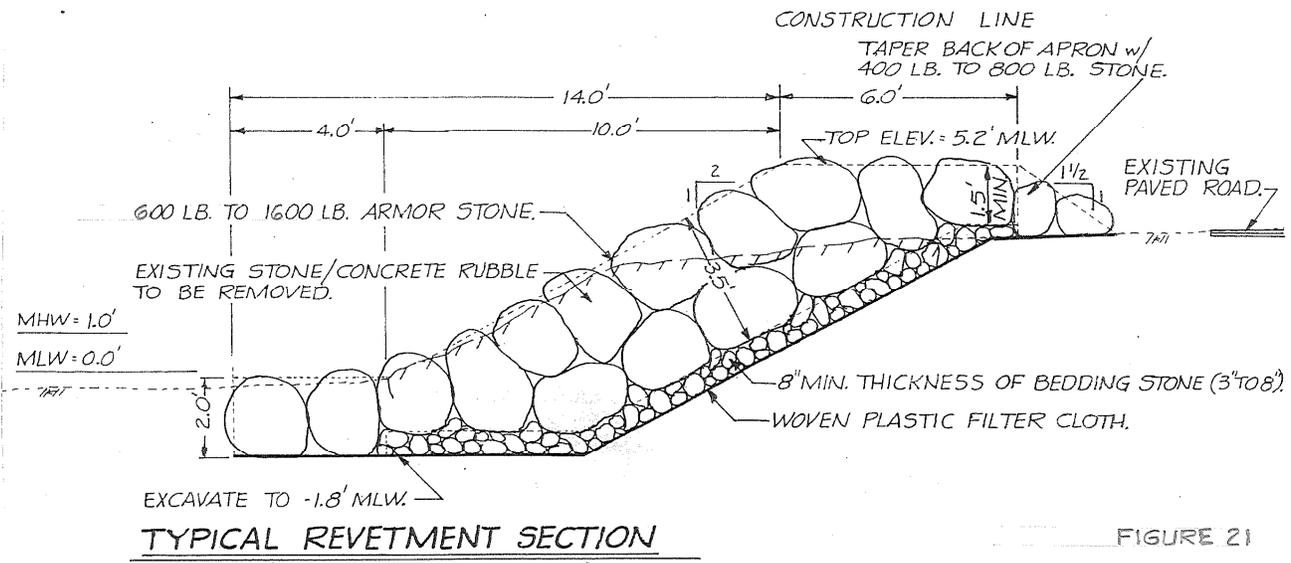
Figure 21

- **AREA 'G' Sta. 45+00 to Sta. 47+00 [Priority #26]:** Slabs of concrete rubble and Class I Riprap are located approximately 5' from Narraganset Avenue that leads to the southerly peninsula and provides access to four properties. Overhead utilities, including a utility pole positioned within the footprint of the rubble, are located over the dumped concrete/stone material. The County's sewerage system is located within the roadway approximately 15' from the rubble. Portions of the shoreline are actively eroding. In order to maintain access and prevent damage to the existing utilities during severe storm events, AMA recommends construction of a new revetment using 600# to 1600# armor stone as shown in Figure 21. The cost of construction would be on the order of \$75K to \$100K.
