SHORE EROSION CONTROL REPORT

**ARUNDEL-ON-THE-BAY
PROPERTY OWNER'S ASSOCIATION
P.O. Box 4665
Annapolis, MD 21403**

July 2009

ARUNDEL ON THE BAY PROPERTY OWNERS ASSOCIATION ANNE ARUNDEL COUNTY, MARYLAND

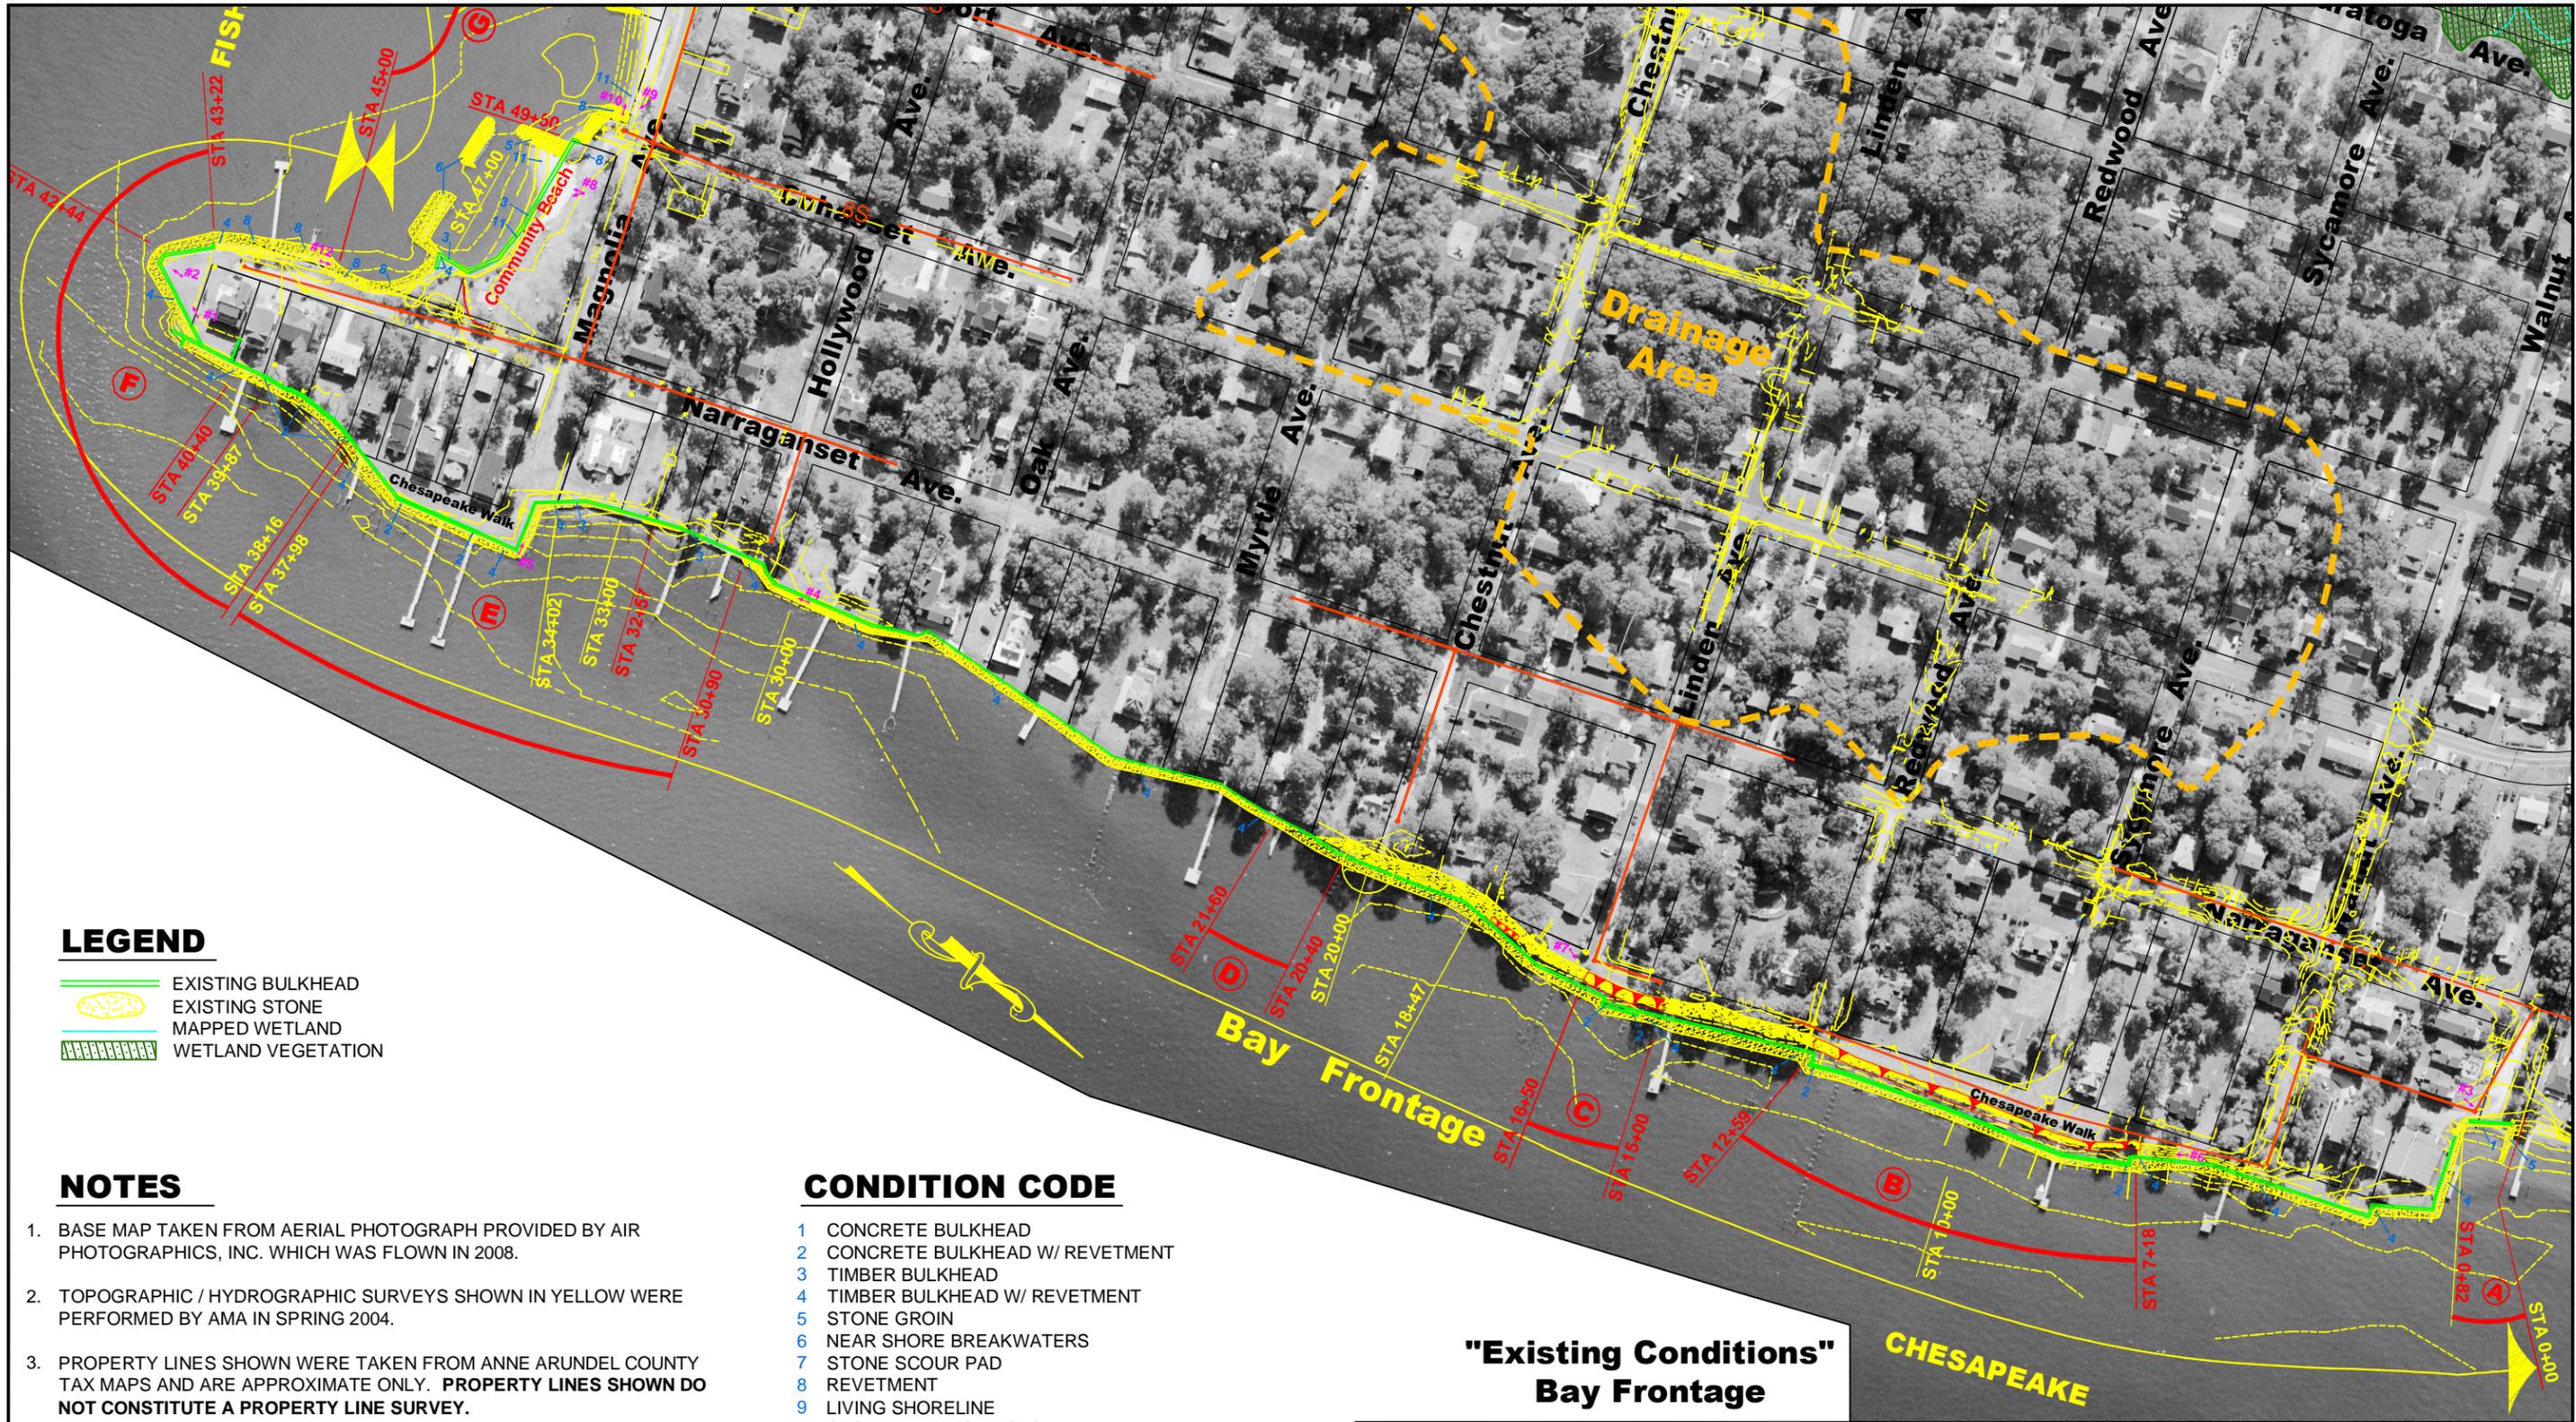
Figure 3

“Bay Frontage”: Approximately 4500' of shoreline along the “Bay Frontage” (Figure #3) extends from Cedar Avenue southerly to the westerly end of Narraganset Avenue. Various existing shore erosion control protection measures include concrete bulkheads, timber bulkheads and combinations of concrete/timber bulkheads supplemented with stone revetments. Newly reconstructed piers along with the decayed remains of storm damaged timber piers and groins are randomly located along the shoreline. A major shoreline improvement renovation project (designed by AMA) was performed during the mid '80s including construction of new timber bulkheads, placement of new and rearrangement/ enhancement of existing armor stone, and repair of many of the existing concrete bulkheads.

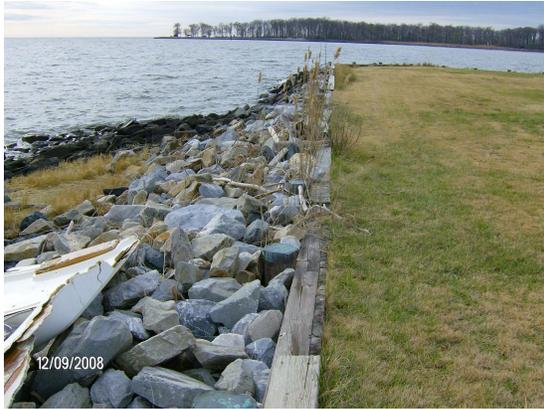
Photo #1

The majority of armor stones at the stone revetments located outboard of the bulkheads appear to be adequately sized for a 25 year storm event (standard used throughout the Chesapeake Bay). The exception is at Narraganset Avenue (Sta. 41+50) (Photo #1) where the range of armor stone is significantly undersized and to a lesser extent south of Chestnut Avenue (Sta. 21+00). Armor stone does not extend to the top of the bulkhead south of Chestnut Avenue (Sta. 21+00), thereby exposing the structure to the ravages of storms. Armor stone located at the point of Narraganset Avenue was catastrophically displaced during Hurricane Isabel but has subsequently been repositioned, apparently re-using the same undersized stone. Erosion land-ward of the shoreline improvement measures at this area has occurred, apparently due to waves overtopping the structure (Photo #2). Based upon design calculations for wave conditions along the Bay Front for a 25 year storm event (Appendix 1), the armor stone should range in size from 600# to 1600# when placed on a 2 horizontal to 1 vertical slope.

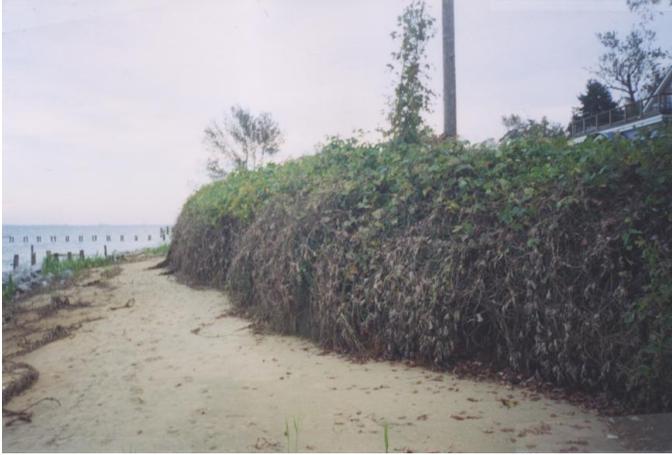
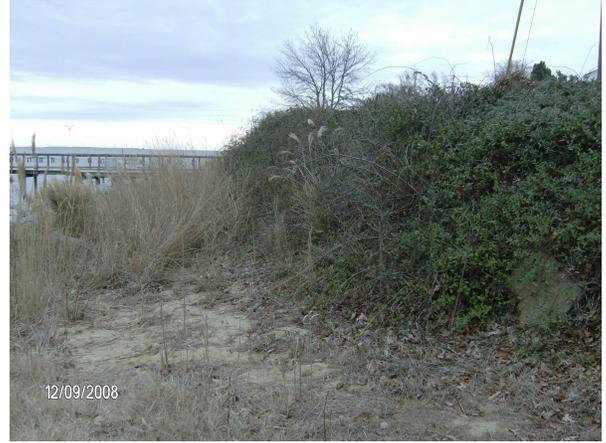
Photo #6 (2004)

Apparently due to the lower elevation of the concrete bulkheads between Sycamore and Redwood Avenues and at Linden Avenue, erosion of the high banks landward and adjacent to the concrete bulkheads occurred during Hurricane Isabel. Further erosion of the bank could potentially threaten the stability of the sewerage system located landward of the banks at this area along Chesapeake Walk. The bank at the northerly end of Chesapeake Walk (about 100' north of Sycamore Avenue) has eroded to within about 15' of the sewer line (Sta. 7+20) (Photo #6). Significant erosion has also occurred landward and adjacent to the storm damaged concrete structure in the vicinity of Linden Avenue (Sta. 15+00) (Photo #7).

The County's sewer line parallels the shoreline from Walnut Avenue to Linden Avenue. During Hurricane Isabel, the bank eroded to within approximately 15' of the sewer line in the vicinity of Sycamore Avenue (Photo #6). Therefore, to prevent further erosion during severe storm events and potential damage to the existing sewerage system, AMA recommends that the concrete structure's surface be parged and any cracks repaired prior to extending the existing stone revetment (located channel-ward of the concrete bulkhead) higher with a stone apron constructed over the bulkhead as shown in Figure 6. Further, the bank should be graded at a stable slope, the kudzu eradicated and the graded bank's surface topsoiled and seeded. The estimated cost of construction is on the order of \$190K to \$260K.

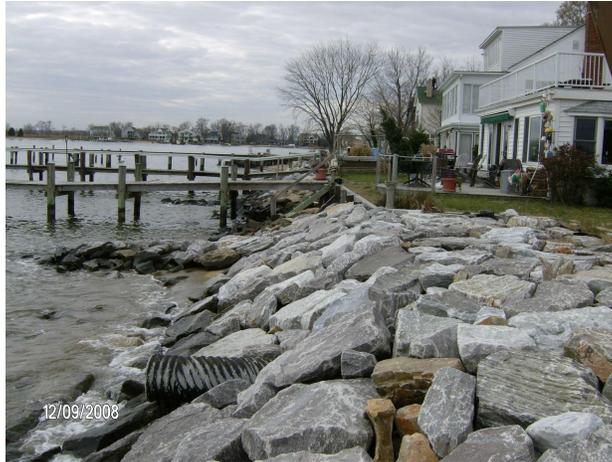
Photo #11

The majority of the armor stones at the stone revetments and the stone revetments located outboard of the bulkheads located east of Saratoga Avenue appear to be correctly sized for a 25 year storm event. The stone revetment at the end of Rockway Avenue (Sta. 56+50) (Photo #11) was constructed in 2008 at a cost of approximately \$700/ linear foot (which includes drainage improvements constructed immediately landward and through the structure).

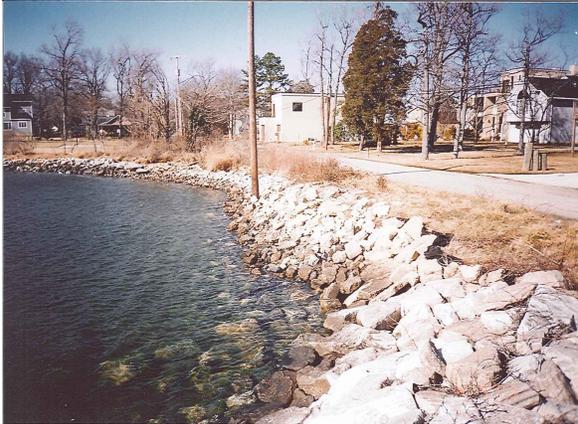
Photo #12

Similar to the “Bay Frontage” conditions, the armor stone size along “The Point Frontage” should range from 600# to 1600# when placed on a 2 horizontal to 1 vertical slope. However, it was noted that combinations of concrete rubble, undersized armor stones, and gabion sized stone were incorporated into the revetments along the northwesterly side of Narraganset Avenue (Sta. 45+00) (Photo #12), the end of Saratoga Avenue (Sta.60+00) (Photo #13), and the end of Magnolia Avenue (Sta. 64+00). Erosion of the shoreline is actively occurring in the vicinity of Sta. 46+00.

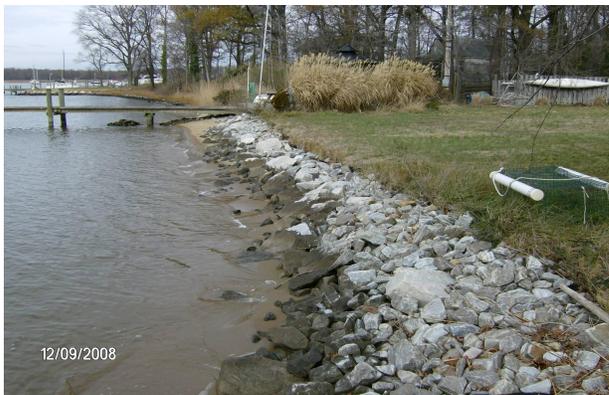
Photo #19

Stone revetments are randomly located along the Fishing Creek shoreline. Types of stone structures include low profile revetments located north of Hollywood Avenue (Sta. 70+00) and between Myrtle and Chestnut Avenues (Sta. 81+00) incorporating small riprap to a high mounded revetment at Niagara Avenue (Sta. 100+00) incorporating large armor stones. Stone located between Linden Avenue and Chestnut Avenues (Sta. 85+30) has no defined shape and appears to have been dumped. Erosion is occurring behind the low profile revetment located north of Oak Avenue (Sta. 75+50) (Photo #19), apparently due to waves overtopping and eroding the ground behind the structure.

- **AREA “L” Sta. 75+00 to Sta. 76+30 [Priority #15]:** Erosion is extending into the lawn behind the low profile stone revetment along the length of the shoreline, apparently due to the lack of filter cloth (along the revetment’s land-ward interface) and wave energy overtopping the structure. AMA recommends that filter cloth be placed under and land-ward of the existing stone and new 100# to 300# armor stone be placed over and land-ward of the existing revetment as shown in Figure 16. The estimated cost of construction is on the order of \$13K to \$18K.

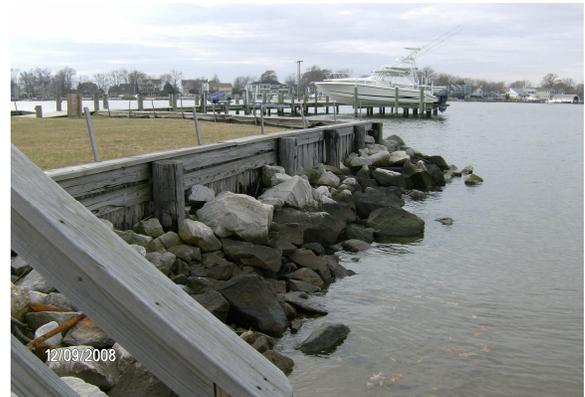
Photo #20

Stone reinforcement is located outboard of the existing timber and concrete bulkheads that protrude into the Creek at Hollywood Avenue (Sta. 68+00) and north of Myrtle Avenue (Sta. 79+50). These stone structures are conservatively sized for a 25 year storm event. Although providing scour protection, the armor stone does not extend to the top of the bulkheads (Photo #20). There is no armor stone outboard of the timber bulkhead at Saratoga Avenue located immediately north of Chestnut Avenue (Sta. 84+00).

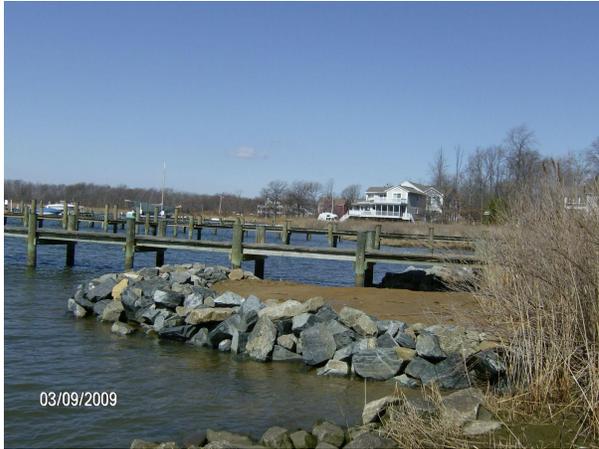
Photo #24

All of these methods have been incorporated as a means of shoreline protection within the Creek to varying degrees of success. A high stone sill has recently been constructed north of Sycamore Avenue (Sta. 95+00) (Photo #24) whereas a low profile stone sill protects the wetlands at the head of the Creek (Sta. 103+60) (Photo #25). Little to no wetland vegetation is growing behind the “Living Shoreline” breakwater system located south of Oak Avenue (Sta. 72+00) or between groins located south of Linden Avenue (Sta. 86+00).

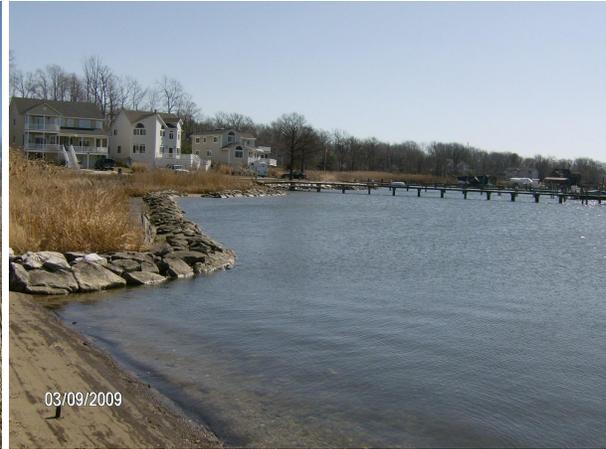
Photo #25

Erosion is occurring landward of the stone sill located south of Chestnut and Sycamore Avenues (Sta. 82+50) as well as south of Sycamore Avenue (Sta. 94+50). This apparently is the result of the top of the sill being too low and the lack of filter fabric up the landward edge of the sill. Waves and high tides overtop the structures and “wash” the sand/ bank material through the stone due to the lack of filter fabric.

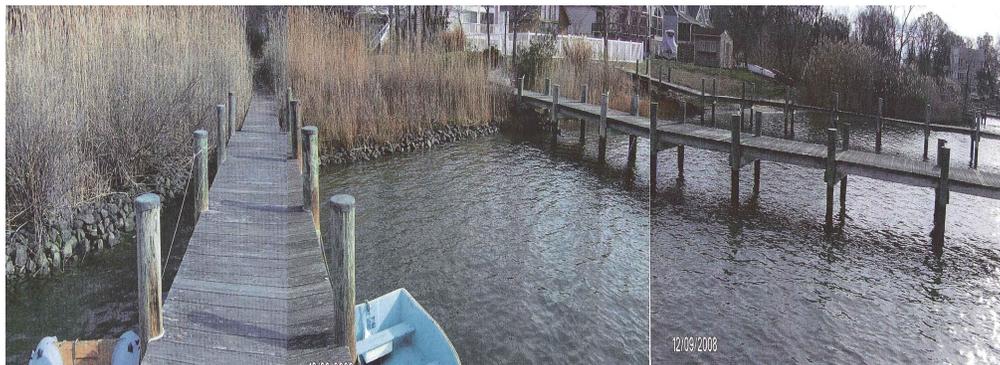
Photo #26

Maintenance of the wetland vegetation is essential to ensure success of a “Living Shoreline” project. Maintenance should include removal of invasive species that migrate into the wetlands (i.e.: phragmites), trimming overhanging limbs to allow sunlight to shine on the vegetation, removal of leaves, flotsam, and other debris which could smother the vegetation, excluding waterfowl into the planted areas, limiting foot traffic, etc. Phragmites, an invasive and aggressive type of vegetation, is established along the shoreline and has invaded and overcome many of the wetland plantings associated with the existing “Living Shorelines” projects (Photo #26). Generally, it appears that maintenance is lacking on the majority of the “Living Shoreline” erosion control projects.

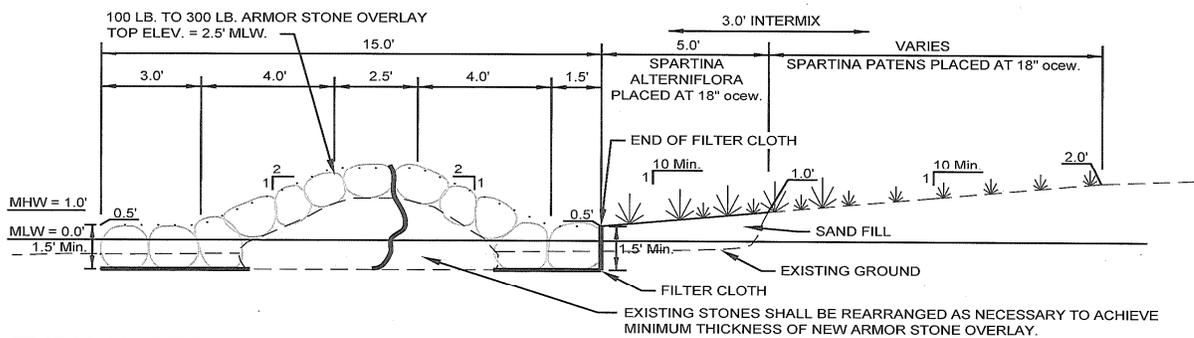
Figure 17

- AREA 'N' Sta. 81+70 to Sta. 83+30 [Priority #12/#16/#18]:** Erosion has occurred land-ward of the stone sill extending into the lawn from Sta. 81+70 to Sta. 82+40; into the phragmites lined shoreline from Sta. 82+40 to Sta. 83+00 and into the outlet ditch from Sta. 83+00 to Sta. 83+30. Similar to the preceding scenario, the lack of filter cloth along the land-ward interface and wave energy overtopping the sill apparently washed the sand (incorporated into the "Living Shoreline" project) out from behind the sill which destroyed the wetland vegetation which started the erosion of the shoreline. AMA recommends that the stone sill be overlaid with new 100# to 300# armor stone to a higher top elevation, filter cloth be placed under and within the structure, the phragmites be eradicated, within the footprint of the proposed sand fill, sand fill be imported and placed between the existing eroded bank and the new sill with the filled areas planted with the appropriate wetland vegetation as shown in Figure 17. The estimated cost of construction is on the order of \$37K to \$50K.

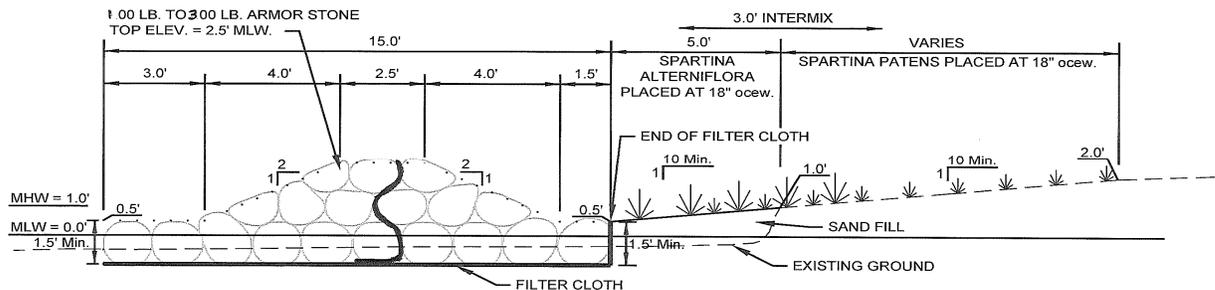
Figure 19

- AREA "0" Sta. 93+70 to Sta. 94+90 [Priority #17]:** Erosion has occurred land-ward of the stone sill extending into the lawn and phragmites lined shoreline. The lack of filter cloth along the land-ward interface and wave energy overtopping the low profile sill has apparently washed the sand (incorporated into the "Living Shoreline" project) out from behind the sill which destroyed the wetland vegetation which started the continued erosion of the shoreline. AMA recommends that the top of the existing sill be raised using 100# to 300# armor stone, filter cloth be placed within the structure, the phragmites within the footprint of the proposed sand fill be eradicated, sand fill be imported and placed between the existing eroded bank and the rehabilitated sill and the filled areas planted with the appropriate wetland vegetation as shown in Figure 19. The estimated cost of construction is on the order of \$20K to \$25K.
